CALIFORNIA DIVISION OF MINES AND GEOLOGY

FAULT EVALUATION REPORT FER-109

SUPPLEMENT NO. 1

Pleasanton fault.

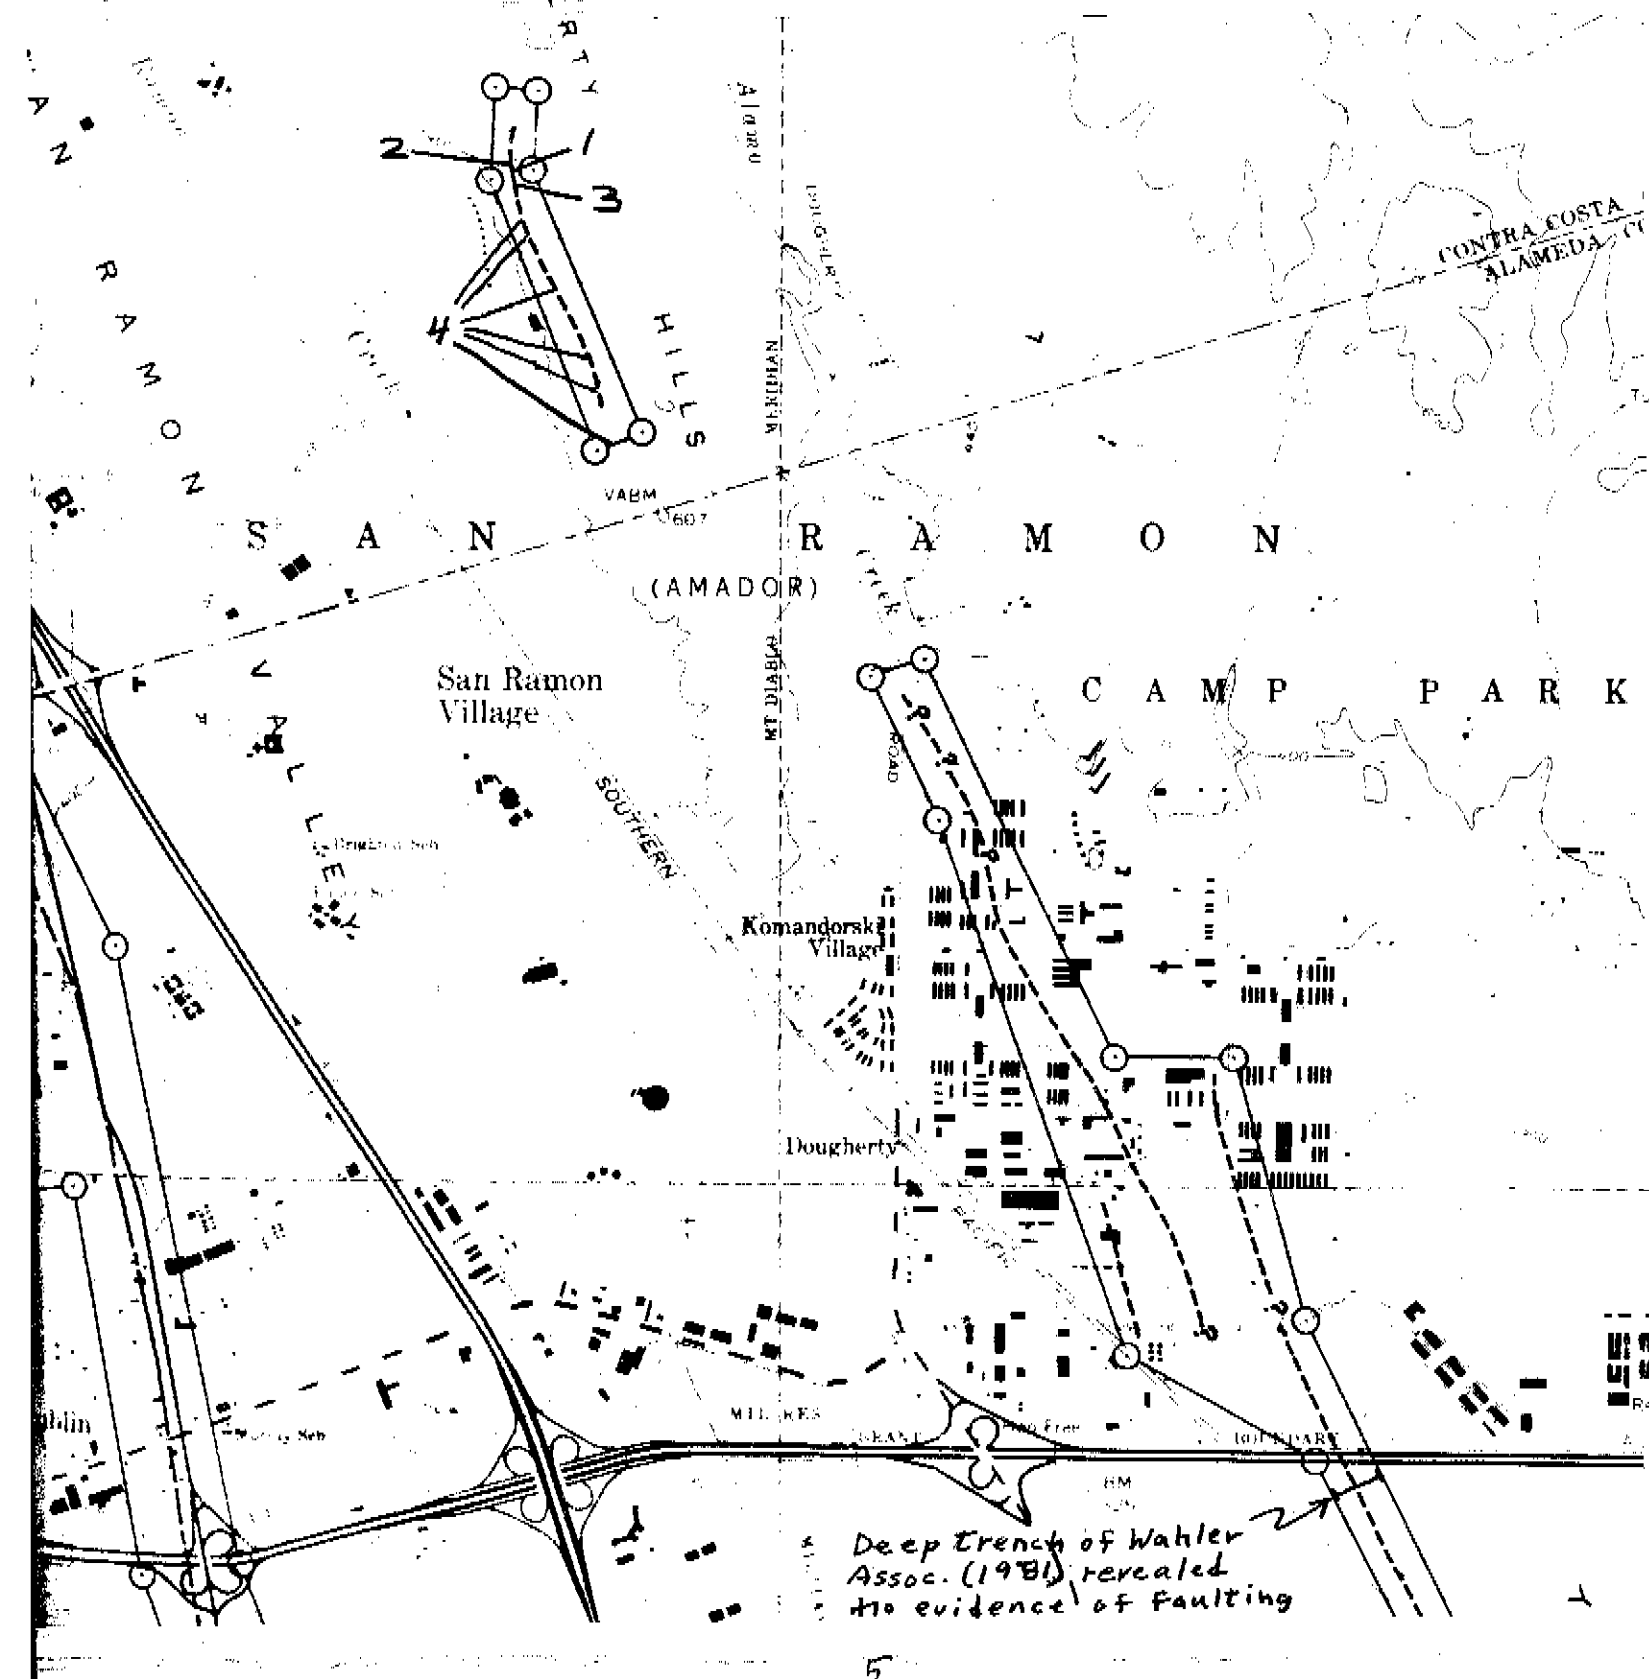
Figure 1 (Supp. No. 1, FER-104). Proposed Special Studies Zones of 7/1/81, Dublin quadrangle. See text for discussion of localities.

A detailed site investigation conducted by Wahler and Associates (1981) south of Highway I-580 has indicated that a segment of the Pleasanton fault is not active. Wahler's conclusion is based on a 15-foot deep trench excavated across the assumed trace of the Pleasanton fault (Figure 1). Trench exposures in alluvium, dated at  $9,770 \pm 400$  years B. P. at a depth of 11.2 feet, showed no evidence of faulting.

In FER-109, Hart (1981b) had concluded that the Dougherty Hills segment of the inferred Pleasanton fault was not well-defined and that geomorphic evidence for Holocene faulting was lacking. The only fault recommended for zoning (Figure 1) was based on evidence of discontinuous minor soil offsets associated with bedrock faults as reported by others (Terrasearch investigations of 1974 and 1979; CDMG file reports C-463, AP 23, AP 1111; see Hart, 1981a).

1. Hump in old Ranch Road -- this broad, linear, north-trending feature aligns with a fault and associated groundwater barrier exposed at localities 2 and 3. The "hump" is formed in the road and curbs and is believed to be due to expansive soils along a fault zone, as there is no evidence of horizontal or vertical offset in the road.

2. A 1979 Terrasearch report (AP 1111) identifies a north-trending, steeply east-dipping fault in bedrock. In trench T-2, an undated "soil mixture" is reportedly offset, but the overlying topsoil is not. A soil "step" of 2 or 3 feet (down to the west) occurs just west of the fault zone, but does not coincide with it. The soil/bedrock interface is uneven, presumably due to several phenomena (e.g., differential soil development, burrowing animals, downhill movement of rock & soil). Trench T-3 (50 feet to the south) shows a similar bedrock fault, but the soil above it is not obviously offset. Again the soil/bedrock interface is uneven, both at the fault and away from it.

3. Terrasearch (1974; CDMG report AP 23) reported a shear zone associated with a "deepening of the soil profile." However, no fault is identified on the sketchy trench log, although the bedrock units are shown to dip steeply to the east.

4. Terrasearch (1979; CDMG report C-463) identified a possibly active fault that was exposed in six trenches (locations identified in Figure 1). Soil reportedly was offset 2.5 feet (east side down) along an easterly dipping fault in trench T-4. This trench, located 550 feet south of Locality 2, was examined on 6/12/79 by this writer, whose notes and sketch log clearly show the soil "offset" to be due to differential burrowing along a minor shear zone in the Orinda Formation. Five other logs of trenches that crossed the inferred active fault to the south revealed no evidence of recent soil displacement. No other evidence for recent faulting was reported anywhere else in the southern Dougherty Hills by Terrasearch, who did extensive trenching throughout the area. Their trench logs, in fact, show numerous other bedrock faults and shears elsewhere in the hills. Many of the shears parallel the bedding.

a. Camp Parks area -- zone only that portion of the inferred Pleasanton fault north of Highway I-580.

b. Dougherty Hills -- do not zone any faults in this area.
